**Region 9 Enforcement Division
75 Hawthorne Street
San Francisco, CA 94105**

Inspection Date(s):	9/30/15		
Time:	Entry: 1:00pm	Exit: 2:15pm	
Media:	Water		
Regulatory Program(s)	Clean Water Act NPDES /CAFO Dairy		
Company Name:	TIVA Dairy		
Facility or Site Name:			
Facility/Site Physical Location:	Ex. 6 Personal Privacy (PP)		
Geographic Coordinates:			
Mailing address:			
Facility/Site Contact:	Dickie Vander Meulen	Title: Owner/Operator	
	Phone: Ex. 6 Personal Privacy (PP)	Email:	
Facility/Site Identifier:	NPDES CAG018001 / Order R8-2013-0001, General waste discharge requirements for CAFOs (dairies and related facilities)		
NAICS:	112120 Dairy Cattle and Milk Production		
SIC:	0241 Dairy Farms		
Facility/Site Personnel Participating in Inspection:			
Name	Affiliation	Title	Email
Dickie Vander Meulen	TIVA Dairy	Operator	
EPA Inspector(s):			
John Tinger	EPA	Engineer	Tinger.John@EPA.gov
Federal/State/Tribal/Local Representatives:			
Edward Kashak	WRCB-R8	Engineering Geologist	ekashak@waterboards.ca.gov

SECTION I – INTRODUCTION

The facility has obtained coverage under NPDES CAG018001 / Order R8-2013-0001, General waste discharge requirements for CAFOs (dairies and related facili

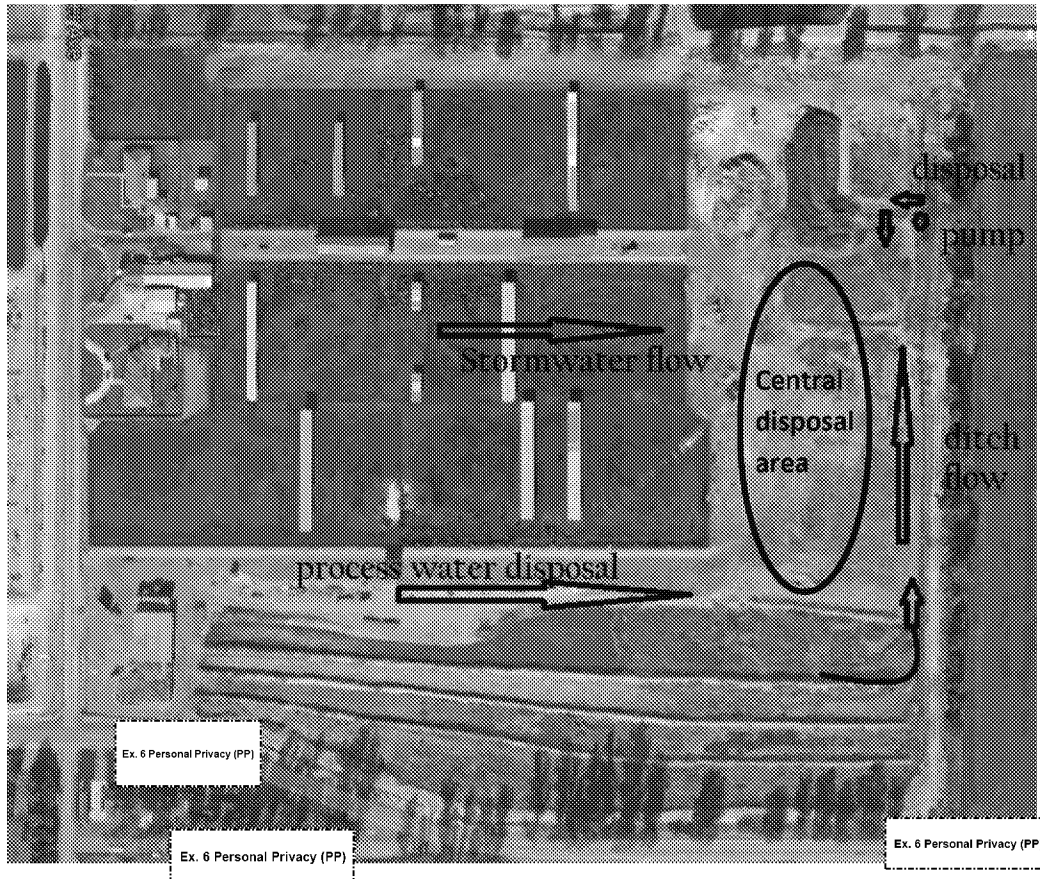
Washwater from the milking barn area gravity drains through underground pipes to the southern portion of the dairy where it is directed to one of 4 standpipes for discharge to the disposal area. The disposal area consists of 4 bermed areas which drain towards the eastern end of the facility. (see photo 1). The operator manually directs the wastewater to one of the 4 standpipes. At the time of the inspection, wastewater was actively flowing into the 2nd northernmost bermed area (photo 3). The operator stated wastewater has been directed to this bermed area for approximately 2 weeks. Previously, the northernmost bermed area had received wastewater (photo 4). At the time of the inspection, the solids in the northernmost area had been drying for approximately 2 weeks, and the operator stated he anticipates removing the solids within the month when the solids are sufficiently dry to accommodate equipment.

1 – Facility overview.

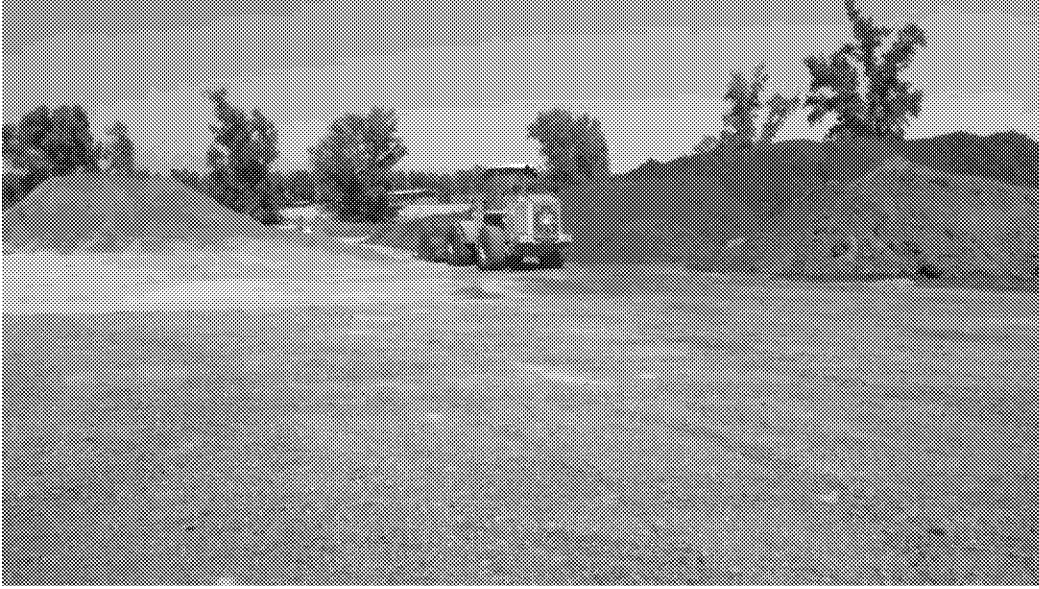
No issues noted. Stockpiles of manure did not appear to have been present for more than 180 days.

Photo 2: Manure stockpiling

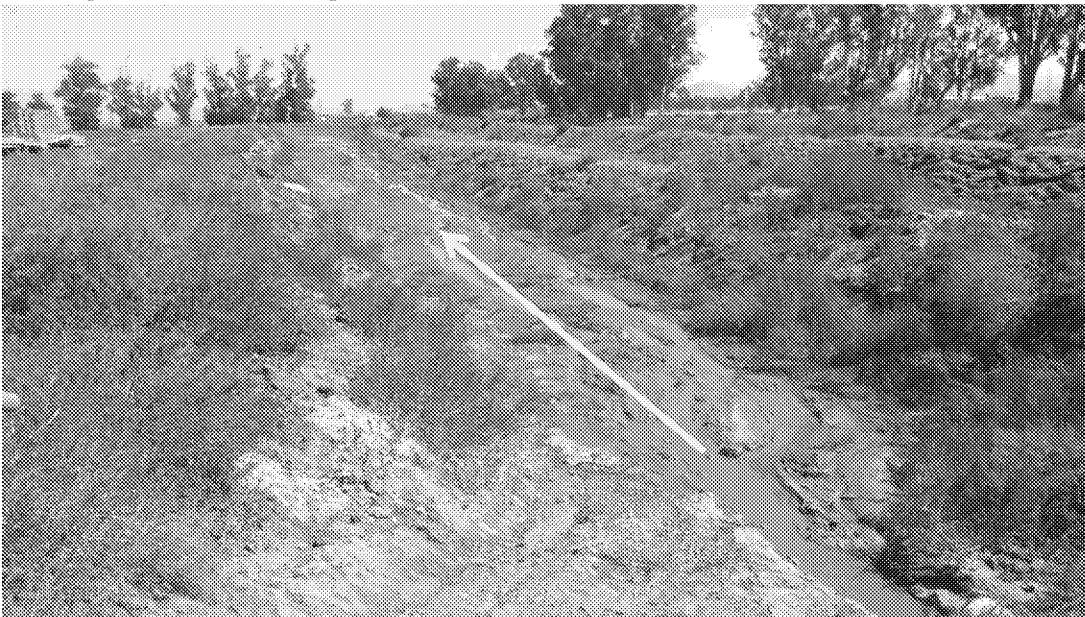
Photo 3: 2nd (from north) bermed area actively receiving washwater from standpipe and flowing east. View looking east.

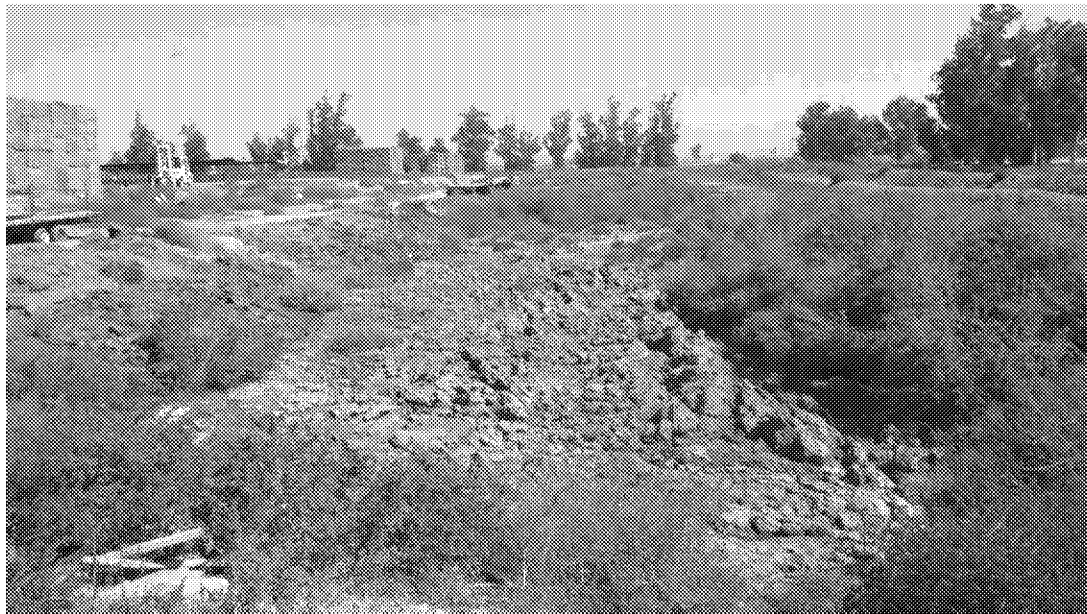
Photo 4: 1st (northernmost) bermed area with solids. View looking east.

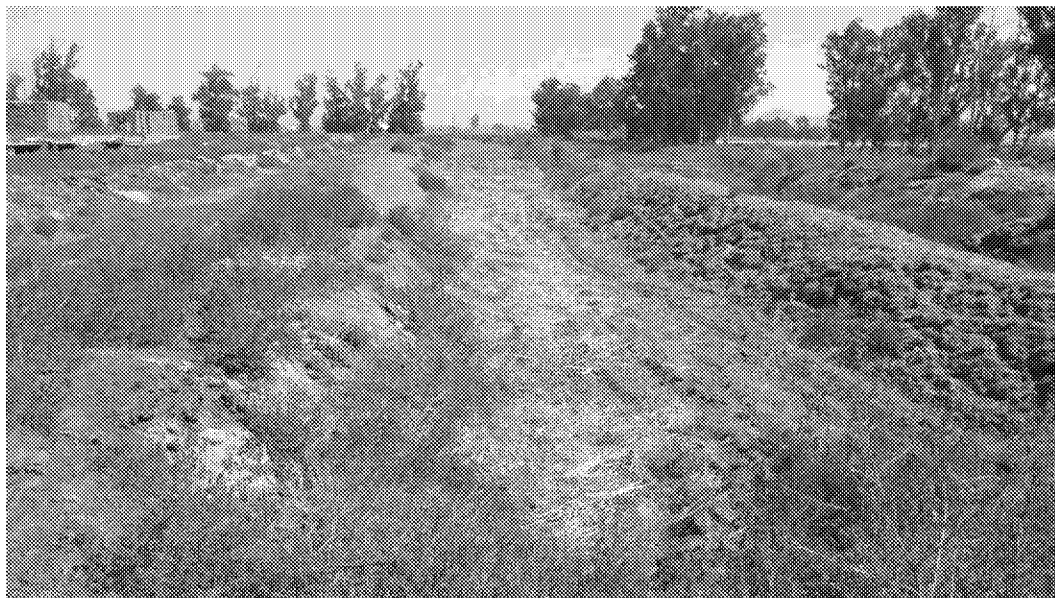
Photo 5: 3rd (from north) bermed area inactive after solids have been removed. View looking east.

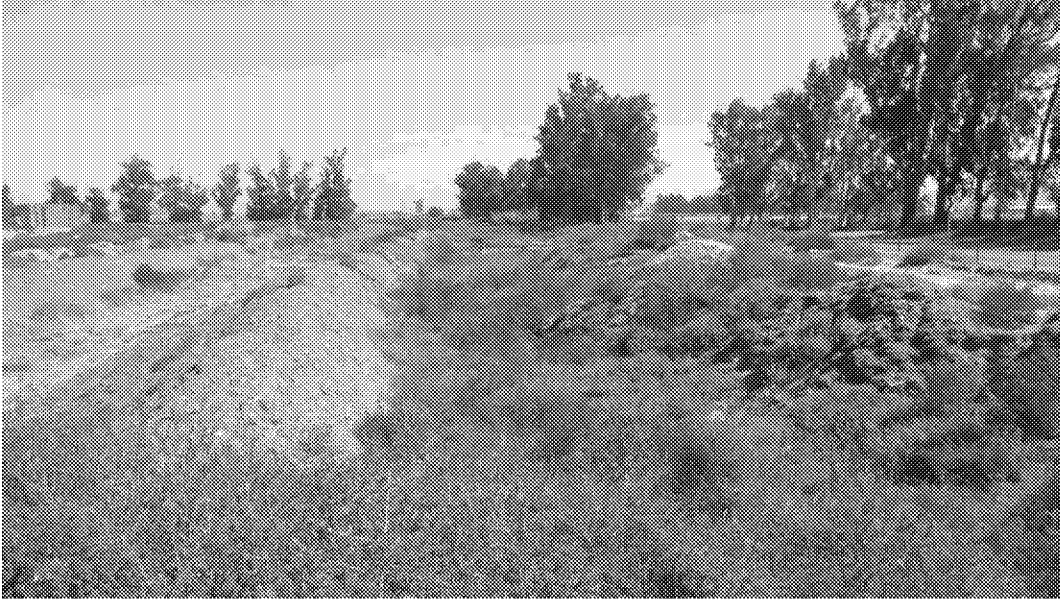
Photo 6: 4th (from north) bermed area inactive. View looking east.

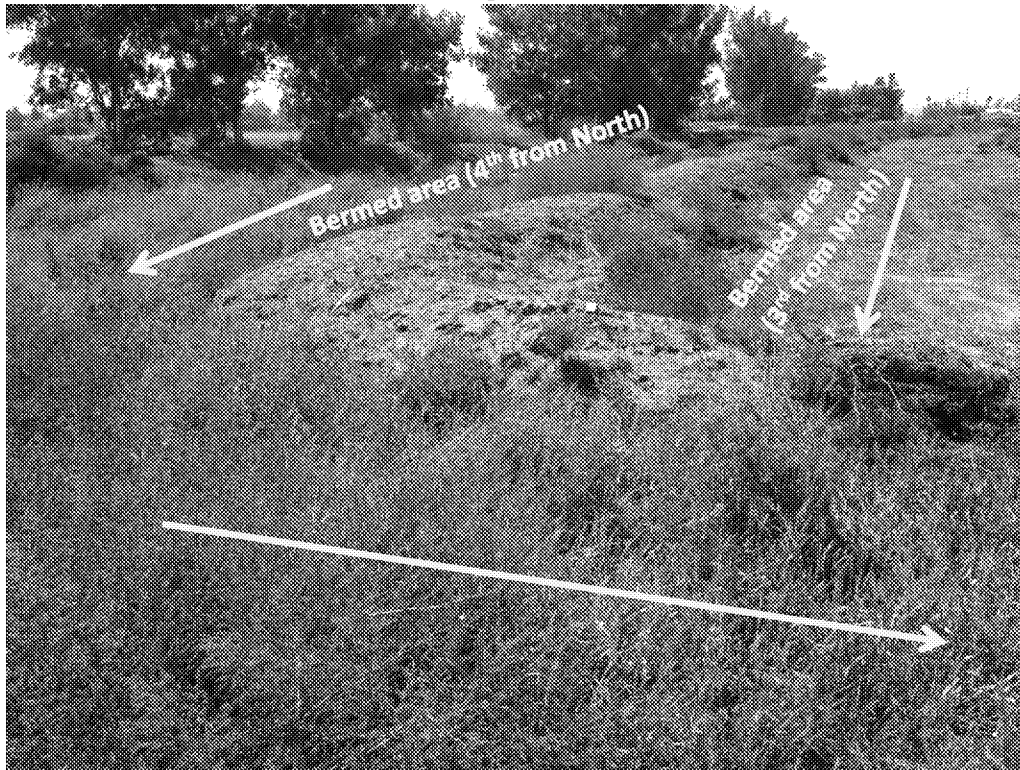
Photo 7: Southeastern edge of facility. Bermed areas turn corner and flow is directed northerward into ditch. View looking west.

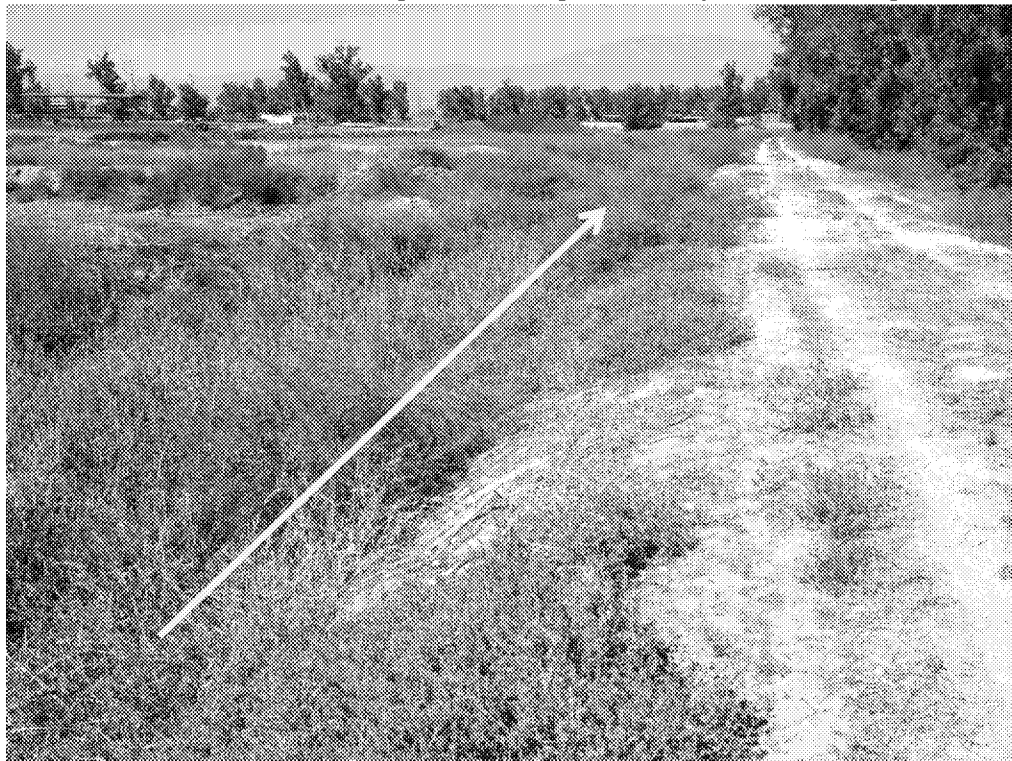
At the eastern end of the bermed areas, the berms are several feet lower to create a spillway into a ditch running alongside the eastern boundary (photo 8). The ditch was observed to contain heavy vegetation cover, especially in the southeast corner. The ditch directs wastewater northward back towards the center of the facility. At the end of the ditch, the operator has installed a pump (photo 10). When the ditch is full, the operator pumps wastewater to the northernmost disposal area where it infiltrates (photo 11). Excess wastewater from this pasture area may overflow to the center disposal area (photo 12).

Exterior berms appeared to be properly constructed. No rodent holes observed, minimal vegetation along tops of berms. Excess vegetation observed in ditches alongside berm.

Photo 8 : Ditch and berm along eastern edge of facility. View looking North.

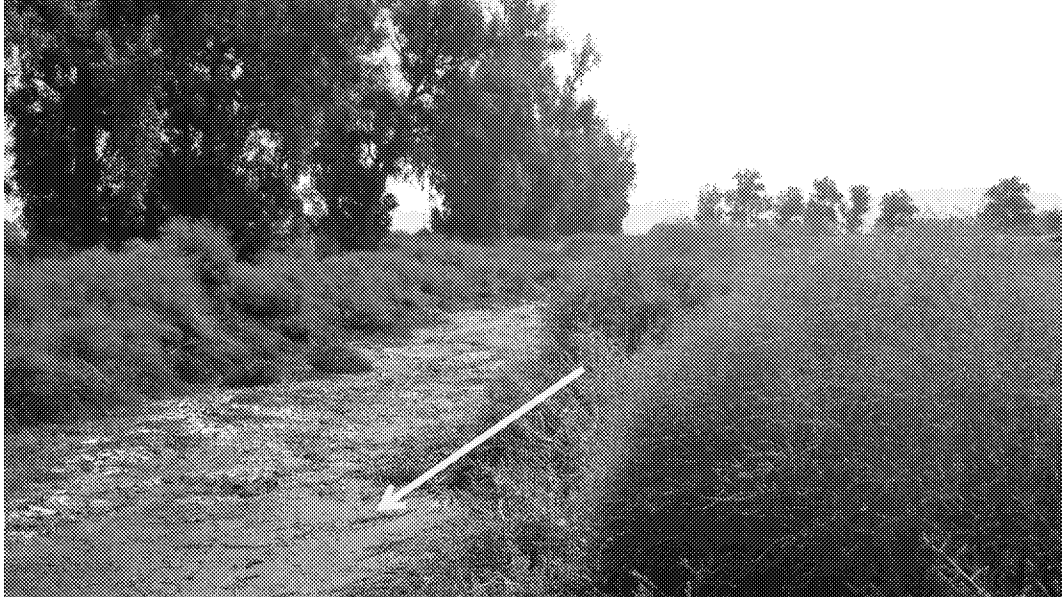
Photo 9: Ditch and berm along eastern edge of facility. View looking south.

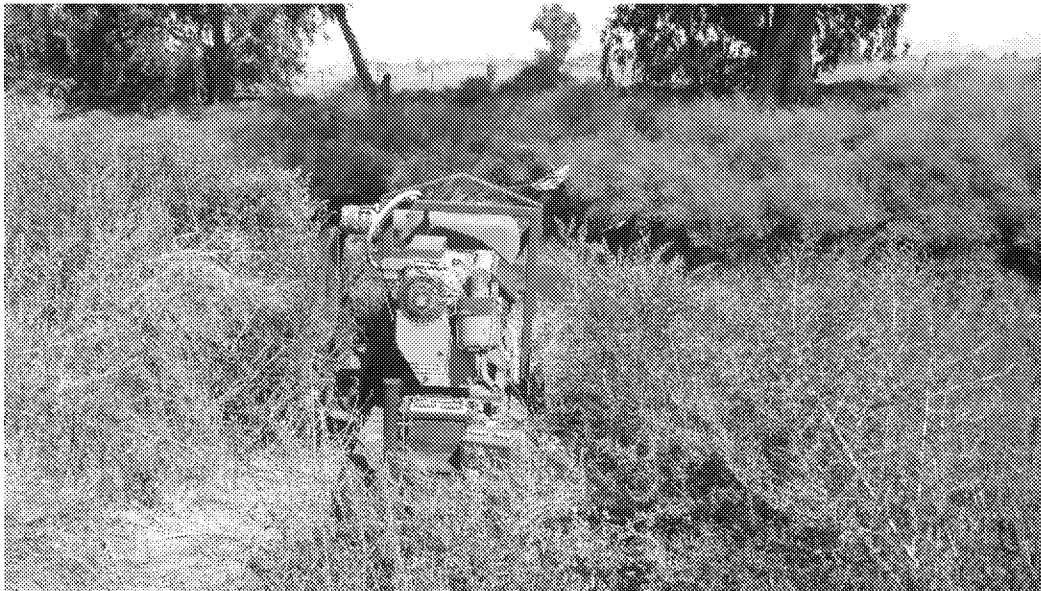
Photo 10: Pump in ditch

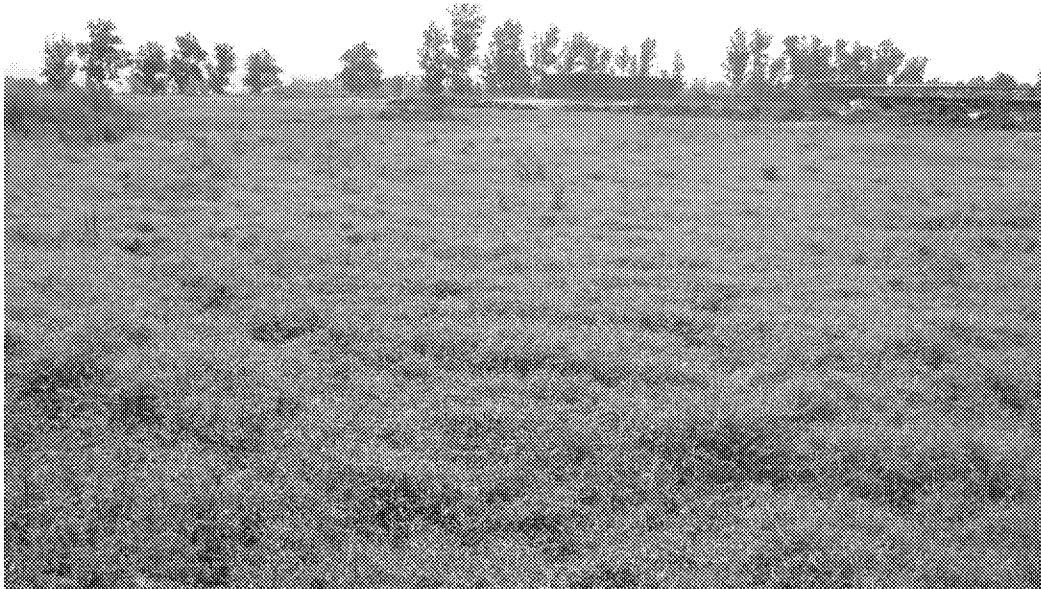
Stormwater generally flows from the corrals towards the center and easterly direction to the disposal areas (photo 12). The soils in the disposal area were observed to be sandy and very porous. The operator noted the high percolation rates in this area, and stating that 2' of water will drain overnight. The operator rips the disposal area as needed to encourage infiltration in this area. The operator recently bought a new disc ripper to facilitate ripping the area.

Photo 12: disposal area in center of eastern section of facility. This area receives stormwater flow from corrals, and receives any overflow from the disposal area in photo 11. The area is disked to promote infiltration. View looking northwest.
